Natural hazards and cultural heritage in Florence: the slope instability story of *Monte alle Croci*

Canuti P.¹, Casagli N.¹, Fanti R.¹, Agostini G.², Margottini C.²

ABSTRACT. Monte alle Croci was the scenery of many historical and artistic events since the Roman period and played an important role in the history of Florence. Some of these facts are connected with the slope instability of the area, firstly investigated by Leonardo da Vinci. The current urban layout, projected by Giuseppe Poggi when the city became the capital of Italy (1864-1877), is a response to these landslide problems. In this paper a review of the instability evolution throughout the last five centuries is presented and it is aimed to frame the present monitoring instruments. A large network of extensometers, inclinometers and piezometers is actually working, even if the data are not easily interpretable. Additional information is expected from some new instruments set up in 2002 and from the reconstruction of the past earth handling.

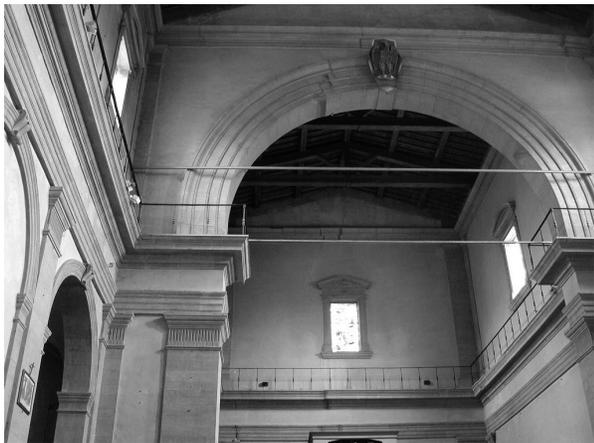
FIG. 3 – The interior of San Salvatore al Monte: on the arch some old restored cracks are evident.

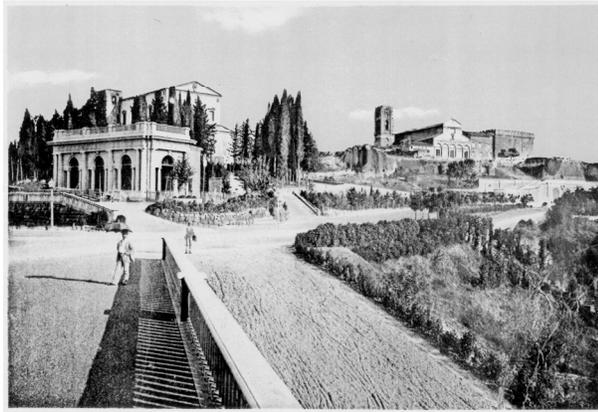
FIG. 5 – San Miniato, San Salvatore and Piazzale Michelangelo during the Poggi's works (from FANELLI, 1973).

Until the 19th century, the hill remained untouched by building works; then, in 1865, the construction of the monumental cemetery (called *Cimitero delle Porte Sante*) started, immediately followed by the beginning of the city transformation works linked to the appointment of Florence as capital of the Kingdom of Italy. Indeed, between 1865 and 1876, *Monte alle Croci* was involved in a radical town planning intervention directed by the engineer Giuseppe Poggi. On the hill, Poggi designed the scenographic *Viale dei Colli* with its panoramic open squares, of which *Piazzale Michelangelo* is the most famous (FIG. 5) (POGGI, 1872; 1882; BARGELLINI, 1980).

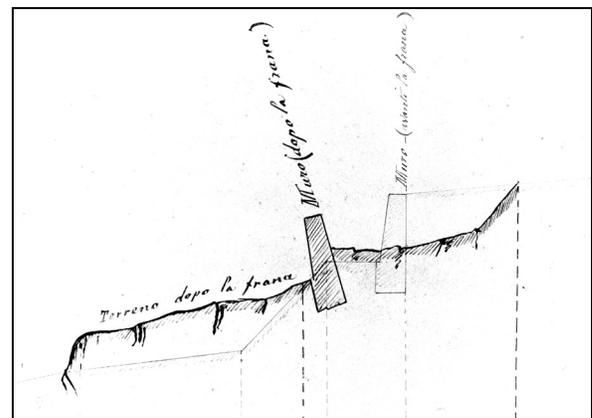
FIG. 6 –Poggi's original drawing of a landslide occurring during the construction of Piazzale (POGGI, 1872), showing the slope profile before (thin stroke) and after the event (thick stroke).

Twelve years after, Poggi had started his project, and, being aware of the problems of the hill, he addressed the works to achieve a more stable layout (FIG. 6): in spite of this, in 1878-79, after heavy rainfall, several cracks opened

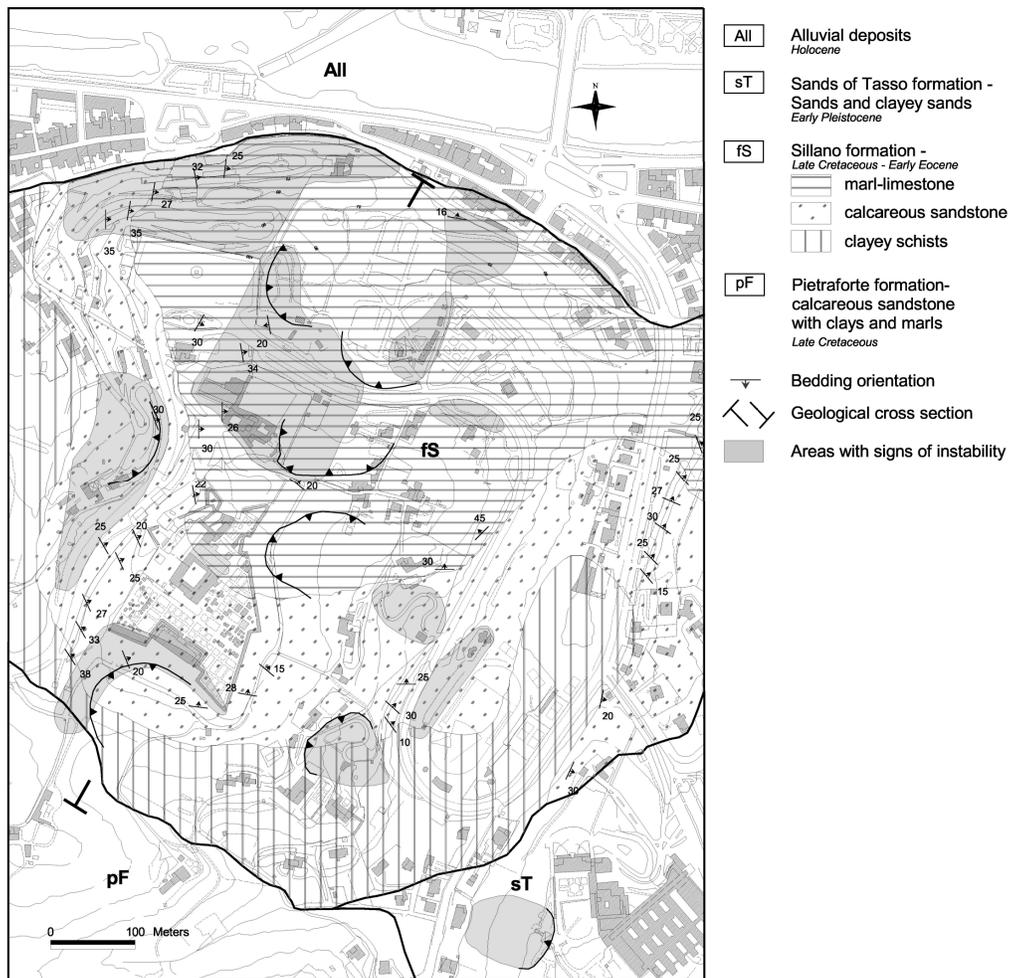
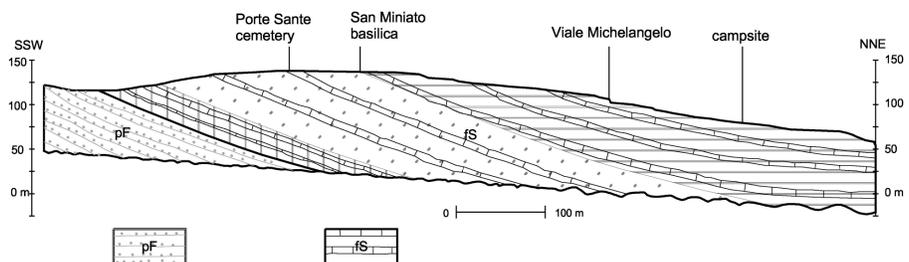
FIG. 7 – Geology and geomorphology map.

The rocks cropping out at Monte alle Croci belong to an allochthonous formation of the Group of Calvana (Cretaceous-Lower Eocene), as the *Sillano formation* (also named *Vallina formation*), constituted by shales with interbeds of limestone, marls and sandstones: in the area it is possible to distinguish three units, on the basis of the prevailing lithology (FIG. 7).

The rock layers are discontinuous and immersed in a clayey matrix, with a stratigraphical orientation of bedding parallel to the slope and dipping NE with angles of between 20° and 30°. The *Pietraforte formation*, constituted by cemented sandstones, borders the southern sector of the area, partially overlapped by Pleistocene lacustrine sands (*Sabbie del Tasso formation*) (FOCARDI, 1991; TADDEI, 1992).

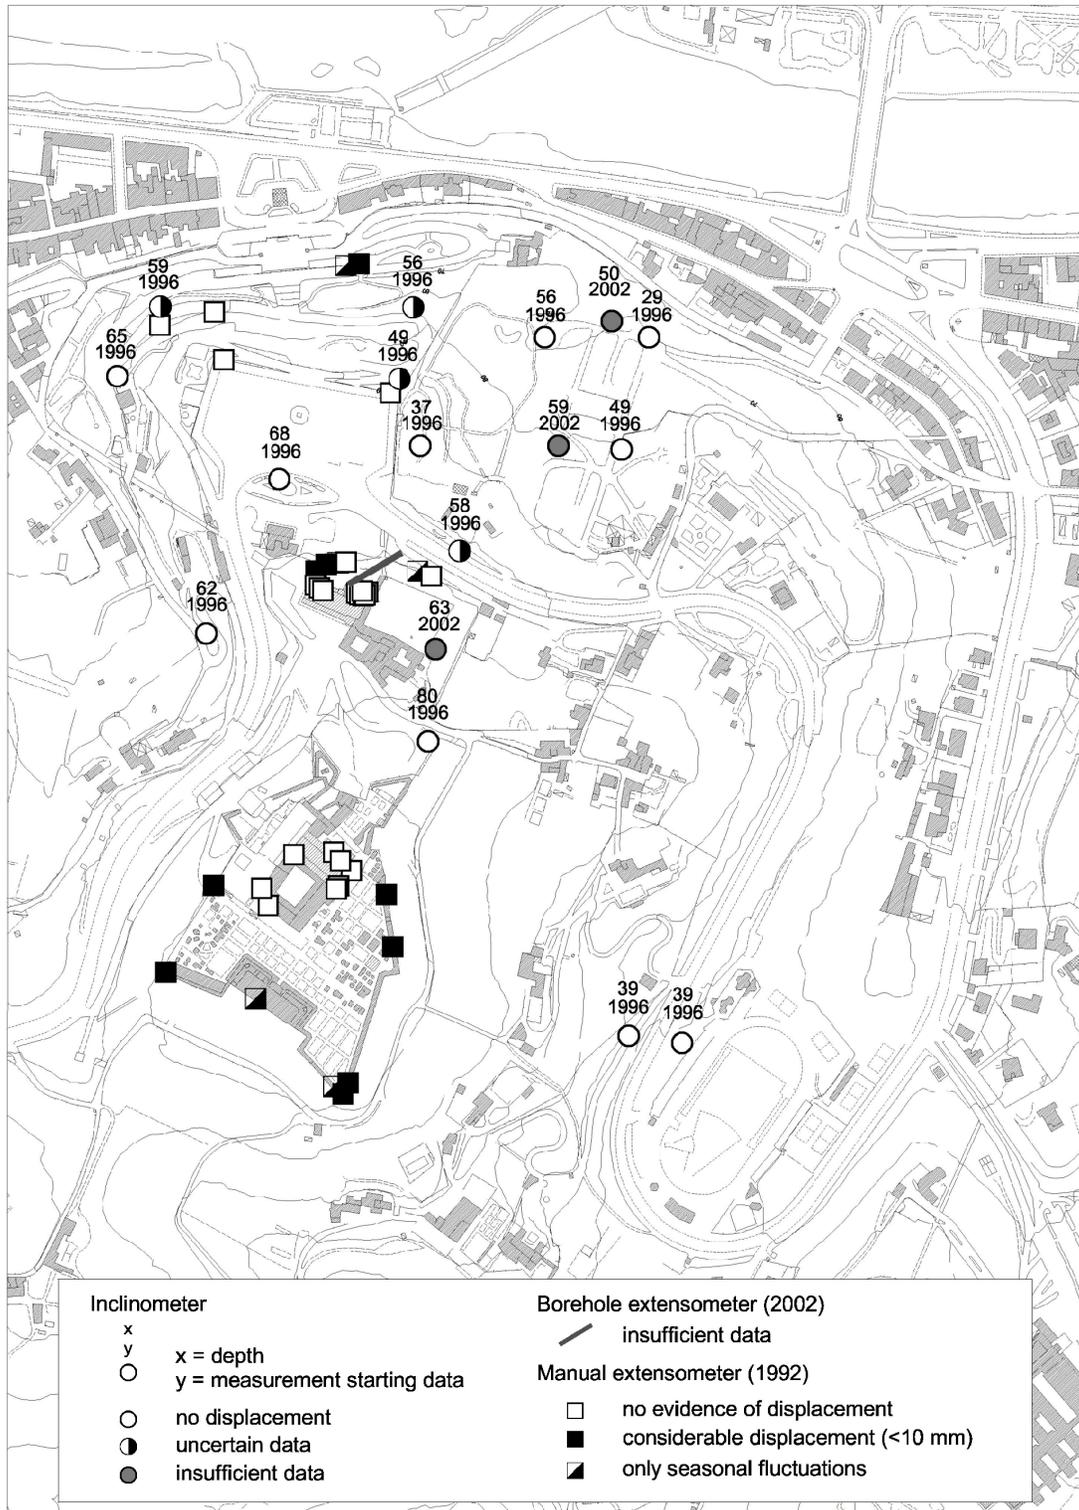
FIG. 8 – Underground and superficial field surveys.

Most of the instruments are still active (FIG. 8), even if the results of field surveys carried out in the past are often difficult to understand, especially comparing data with surface evidence. In particular, some inclinometric records show a certain difficulty for a correct interpretation due to a non-verticality of tubes as well as to their imperfect cementation in the terrain (AGOSTINI *et alii*, 2002a; 2002b; AGOSTINI & FANTI, 2003).

As a general rule, both inclinometers and extensometers have pointed to good stability for the highest portion of the hill where the *Basilica* of San Miniato is sited. On many of the monitored buildings, some seasonal fluctuations have been measured; such fluctuations sometimes show large differences and, in some critical cases, a marked trend, such as in the wall of San Salvatore church. In many cases slope instability is likely associated with a lateral pressure of terrains on the structures rather than to slope instability.

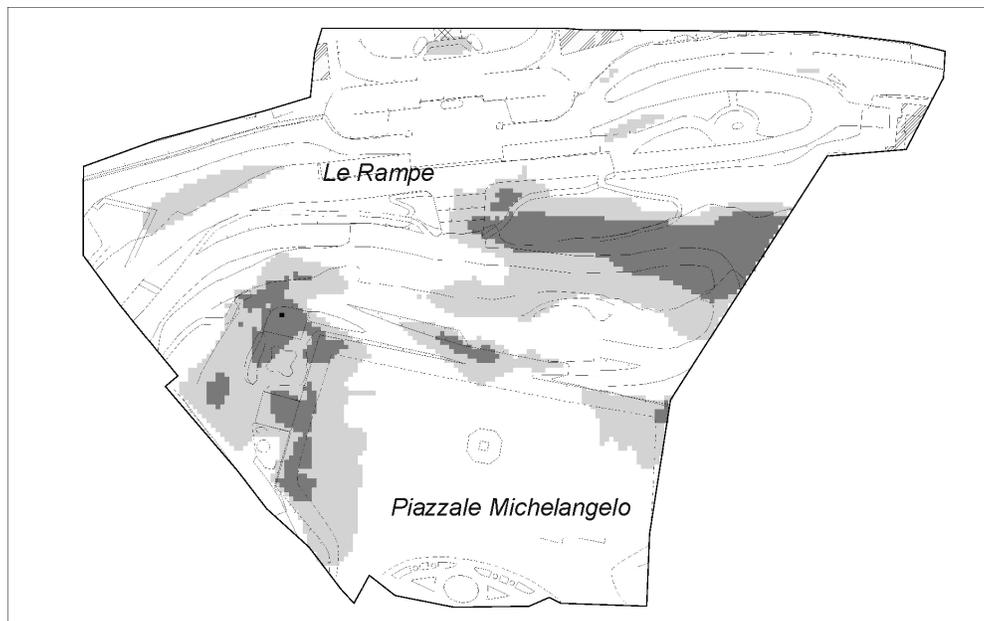
FIG. 9 – Thickness of filling material on the Piazzale and Rampe slope. White: no filling material; light gray: 1-3 m; dark gray: 3-8 m.

With the aim to reconstruct the pattern of debris thickness, a comparison between the topographic data, preceding and following the works, was carried out, using the very detailed information of the report of the Giordano commission and of the ample documentation of Poggi's project (FIG. 9) (POGGI, 1872; 1882; GIORDANO, 1884). Nowadays, the area seems the most critical in terms of geomorphologic hazard and risk for the city's cultural heritage.
