Research on Urbanized Areas Damaged by Natural Processes in Piedmont (NW Italy)

F. Luino

Consiglio Nazionale delle Ricerche (CNR)
Istituto di Ricerca per la Protezione Idrogeologica (IRPI) – Sezione di Torino - ITALY

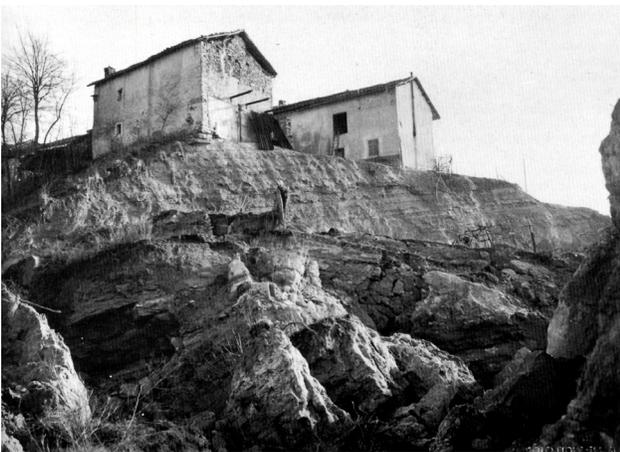
Figure 4 – Cigliè (Cuneo Province). Rock-block slide of January 1963: 10 buildings damaged and 17 others evacuated.

Langhe and Monferrato Hills (SE Piedmont), where the lithological features and the attitude of the strata represent the main predisposing causes for rotational and translational landslides (Cigliè, Levice and Montecastello). Similar processes, including rockfalls (Bertodasco and Piandellera), have involved large areas of the Alpine valleys, where two villages (Quassolo and Baio Dora) were damaged by debris flows. In the Alpine and the hilly sectors, the largest landslides, were reactivations of past phenomena, with long quiescent periods interrupted by further movement. This has sometimes caused severe damage (e.g. Civiasco in October 1857 and November 1951; Cigliè in 1860 and January 1963 (FIG. 4); Montecastello in 1814, 1841, May 1941, December 1959 and March 1978 (FIG. 5).

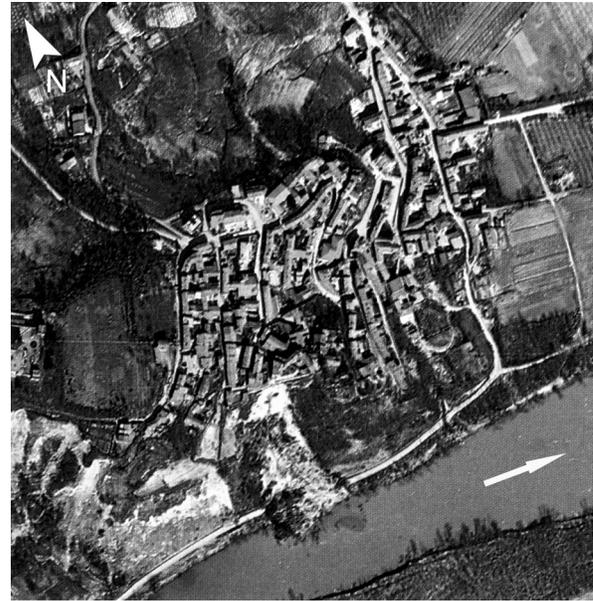
Figure 5 – Aerial photograph of the village of Montecastello. The slump-earth flow of 9 March 1978 is clearly visible on the southern slope. The displaced material partially dammed the Tanaro riverbed.
