the story of the Vaiont landslide

told through the photographs of Edoardo Semenza

The Aim of the Exhibition

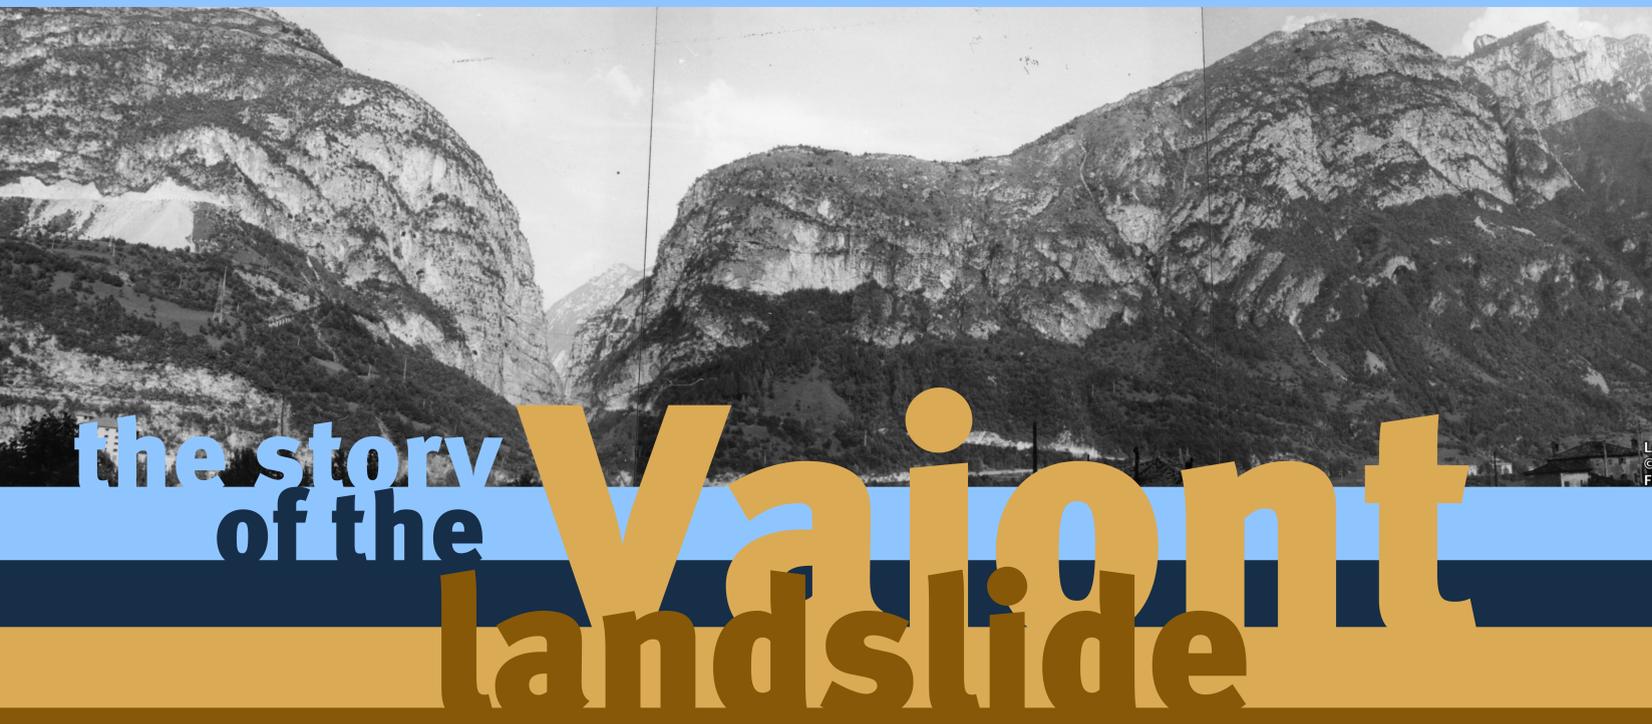
1* - The east slope of the Piave Valley, from Longarone; to the right, Monte Toc
Photo Edoardo Semenza, July 1959
from *Le foto della frana del Vajont - GS_1*

Note the dips of the sedimentary layers on the two sides of the gorge and up to the summit of Monte Toc, and compare them to what Semenza showed in the geological section 3 km farther east.

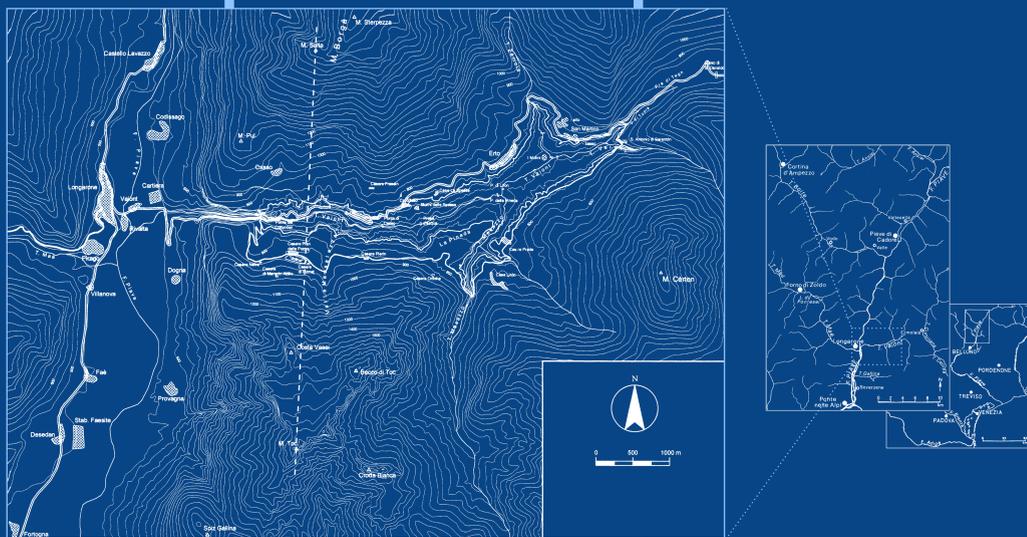
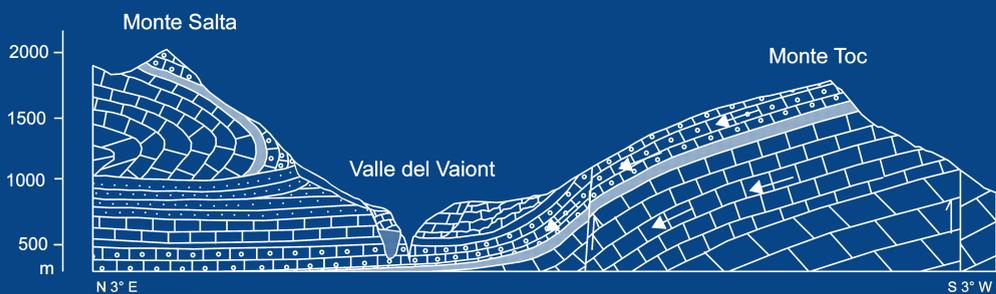
A* - North-south geological section from Monte Salta to Monte Toc, before October 9, 1963

The shape of the north slope of Monte Toc reflects a “chair-like” rock structure, with the bedding planes dipping gently at the foot of the slope and steeply uphill. The section is plotted on the map above.
