Morphology of the Vaiont Valley: the first clues of the paleolandslide

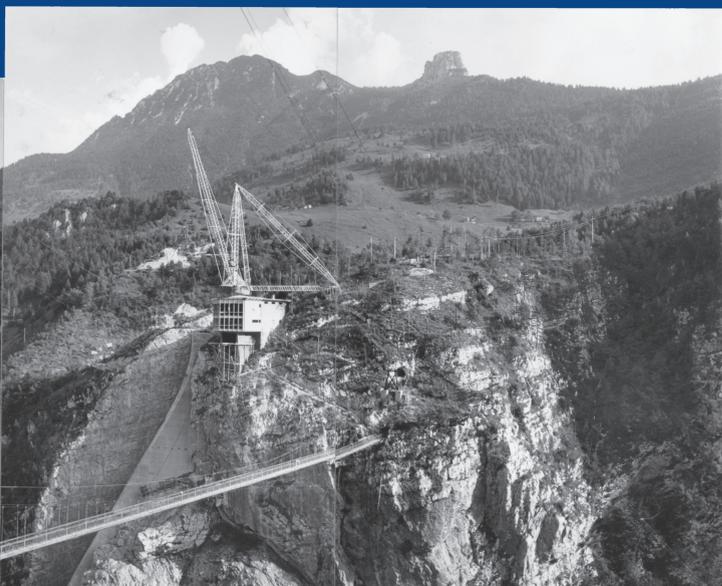
2 - The north slope of Monte Toc from the north side of Vaiont Valley, with the ancient landslide mass in the middle ground and on-going construction on the dam

Bedding layers in the Vaiont Limestone in the foreground dip regularly to the east.

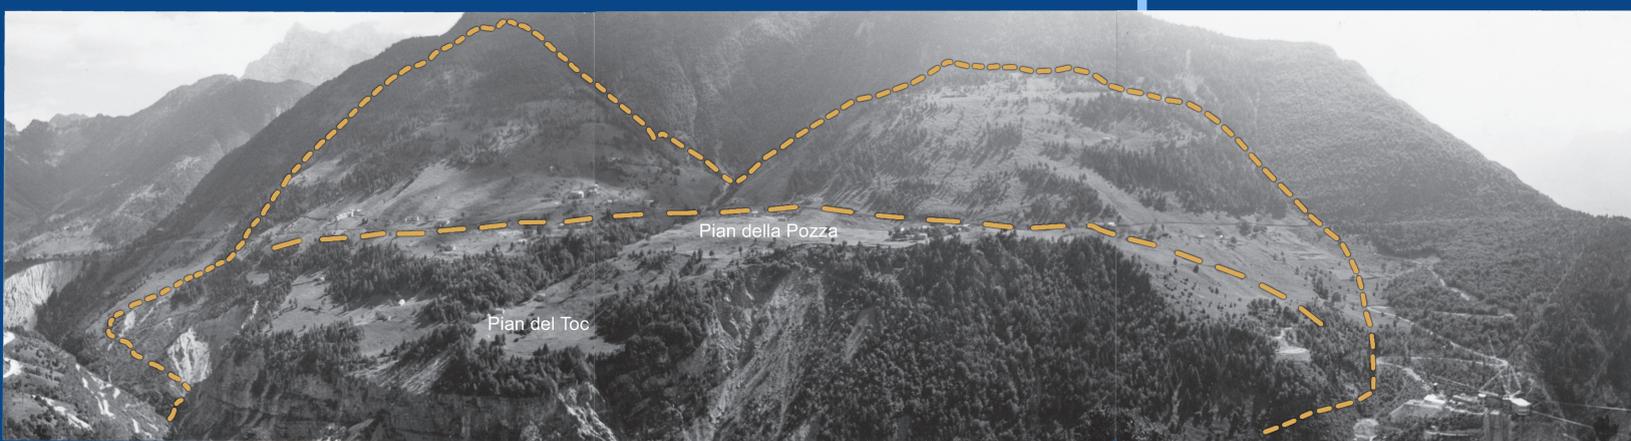
3 - The north slope of Monte Toc from Casso

The control cabin of the dam can be seen at the lower right. The slope is bisected by the Massalezza Stream. To its right, in the center of the photograph, are the Pian del Toc (smaller) and Pian della Pozza (larger) plateaus.

The two sets of dashed lines indicate the upper margin of the ancient landslide: the lower line shows the hypothesis of Edoardo Semenza in 1959; the higher line was based on the results of drillholes and his surveys in the summer of 1960.

In 1959, Edoardo Semenza hypothesized the presence of the upper margin of the ancient landslide at the height of Pian della Pozza (see figure 3).

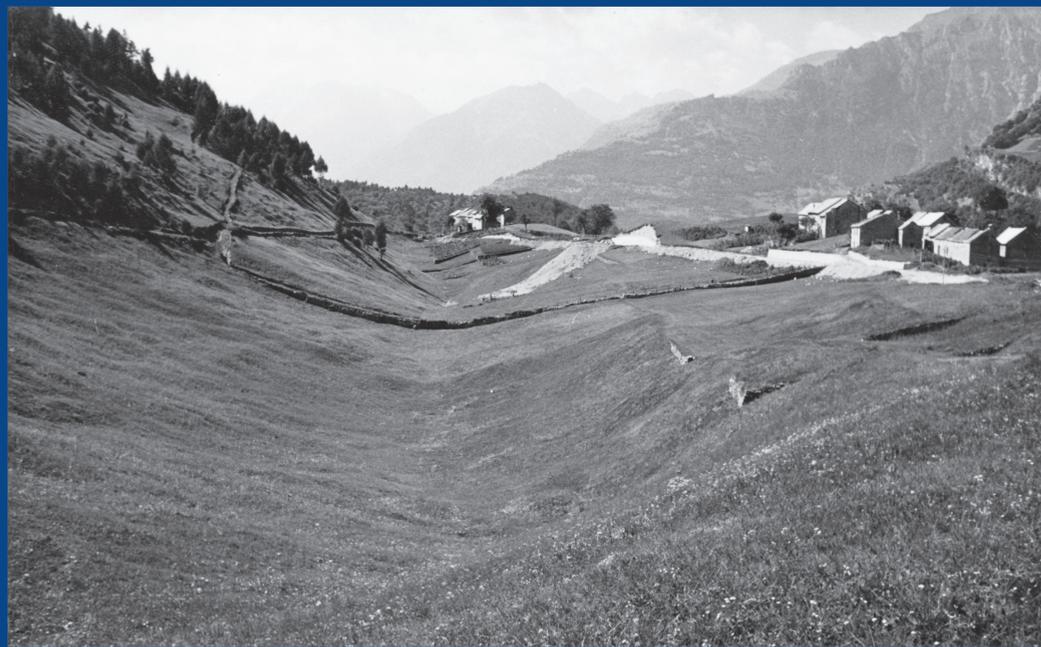
4 - The depression of Pian della Pozza, seen from the east

This feature is a downward fold in sedimentary rocks, which geologists term a syncline. It had long been interpreted as a doline, which is a solution cavity in limestones.
