The morning after the landslide of October 9, 1963 - 2

D - The numbers on the landslide

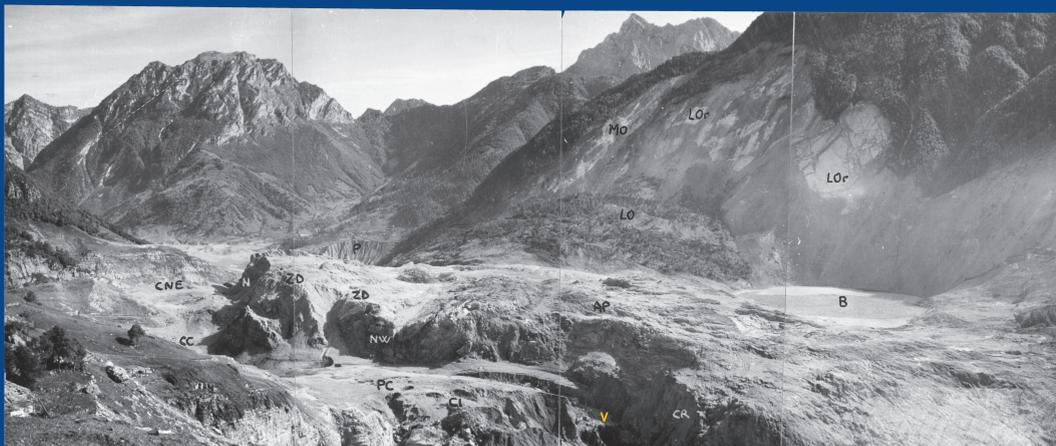
31 - Panorama of the landslide from Casso

Panoramic view from the village of Casso of the Eastern Rocky Slabs of the main scarp (LOr), the Internal Lake (B) and the slide mass. Behind the slide mass are the badlands of the Pineda landslide (P). On the left, the North (N) and Northwest (NW) walls of Punta del Toc, separated from the opposite side of the Vaiont Valley by a series of depressions. Colle Isolato (CI), the Northwest Valley (V) and Costa Rossa (CR) lie below the center of the photograph. Apart from its front, the surface of the slide mass has a gentle shape similar to a plateau. On this surface are the eastern and western Debris Blocks (ZD) and the Pozza Plateau (AP). Near the center of the photo, the steep slope delineates the Col Tramontin fault, which is the East Boundary of the landslide (MO). Between it and the Pozza Plateau, the East Lobe of the slide mass (LO) is also visible; it retained, for the most part, its original vegetation cover.

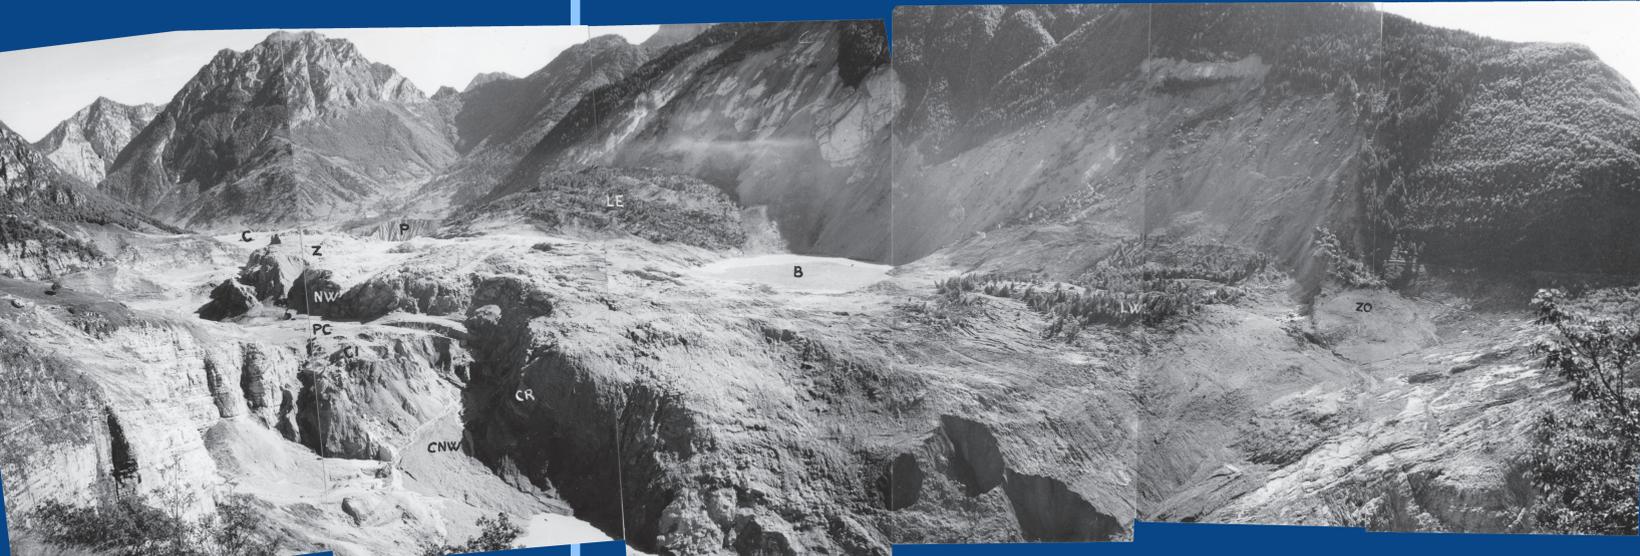
32 - Panorama of the landslide from Casso

One can distinguish almost all the details of the landslide in this panoramic photo. At the lower right are three craters; two more appeared in the following days. At the top are the two parts of the failure surface. Downslope are the two most distal parts of the landslide mass – the two wooded Lobes, LW (western) and LE (eastern) that were not affected by the return flow of water from the displacement wave that completely removed the vegetation from the rest of the slide mass. At the center of the photo is Massalezza Lake (B), which formed at the junction of the eastern and western branches of the Massalezza Stream in the depression created by the back rotation of the slide mass. Water from the displacement wave filled this depression, and the lake persisted for a long time.

At the left, one can see part of the Pineda landslide (P) and the lake upstream of it. NW is the Northwest Wall of the Pian del Toc. ZO is a small mass that began to move with the rest of the slide but then was pushed westward by the principal slide mass and came to rest almost immediately. To the right and below the symbol ZO is the south slope of the valley at the side of the dam, which is composed of east-dipping strata of Vaiont Limestone. Toward the lower left, one can see the alluvial fan (CNW) that formed immediately after the landslide by the part of the wave that flowed out of the valley along the frontal part of the landslide. Just uphill, this water also cut a small channel that is clearly visible on the light-coloured plain underlain by sediment deposited by the last phase of the wave as it sped toward the dam. To the left of this plain is Colle Isolato (CI).

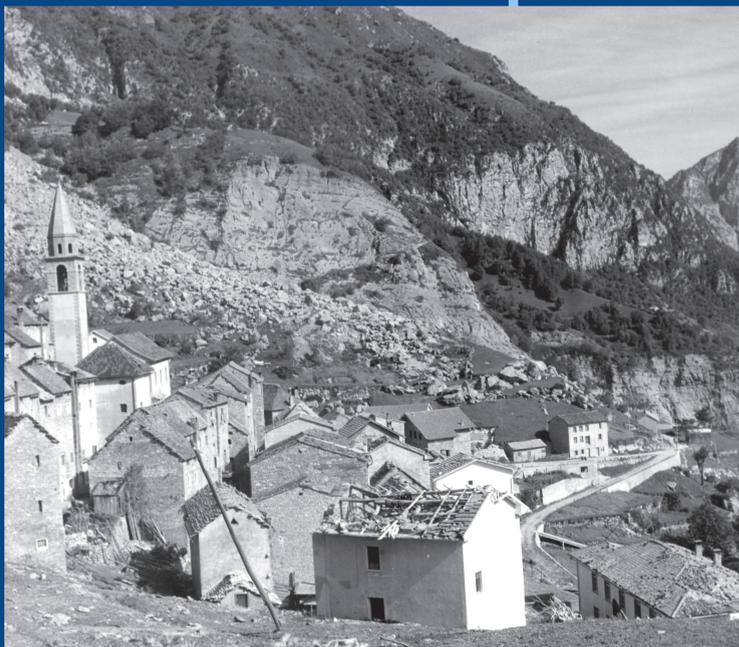
33 - The village of Casso

The village was not directly hit by the wave, but it was damaged by forceful sprays of water and by rocks that were pushed out in front of the wave. Some rocks broke through the roofs of several houses. The most serious damage was done to the house in the foreground and to the school at the lower right.
